UNITED STATES ENVIRONMENTAL PROTECTION AGENCY

SUBJ: EPA Asbestos Removal at 302 Sloan Street

REMOVAL ACTION STATUS REPORT DAVIDSON ASBESTOS

Property Address: 302 Sloan Street, Davidson, Mecklenburg County, North Carolina

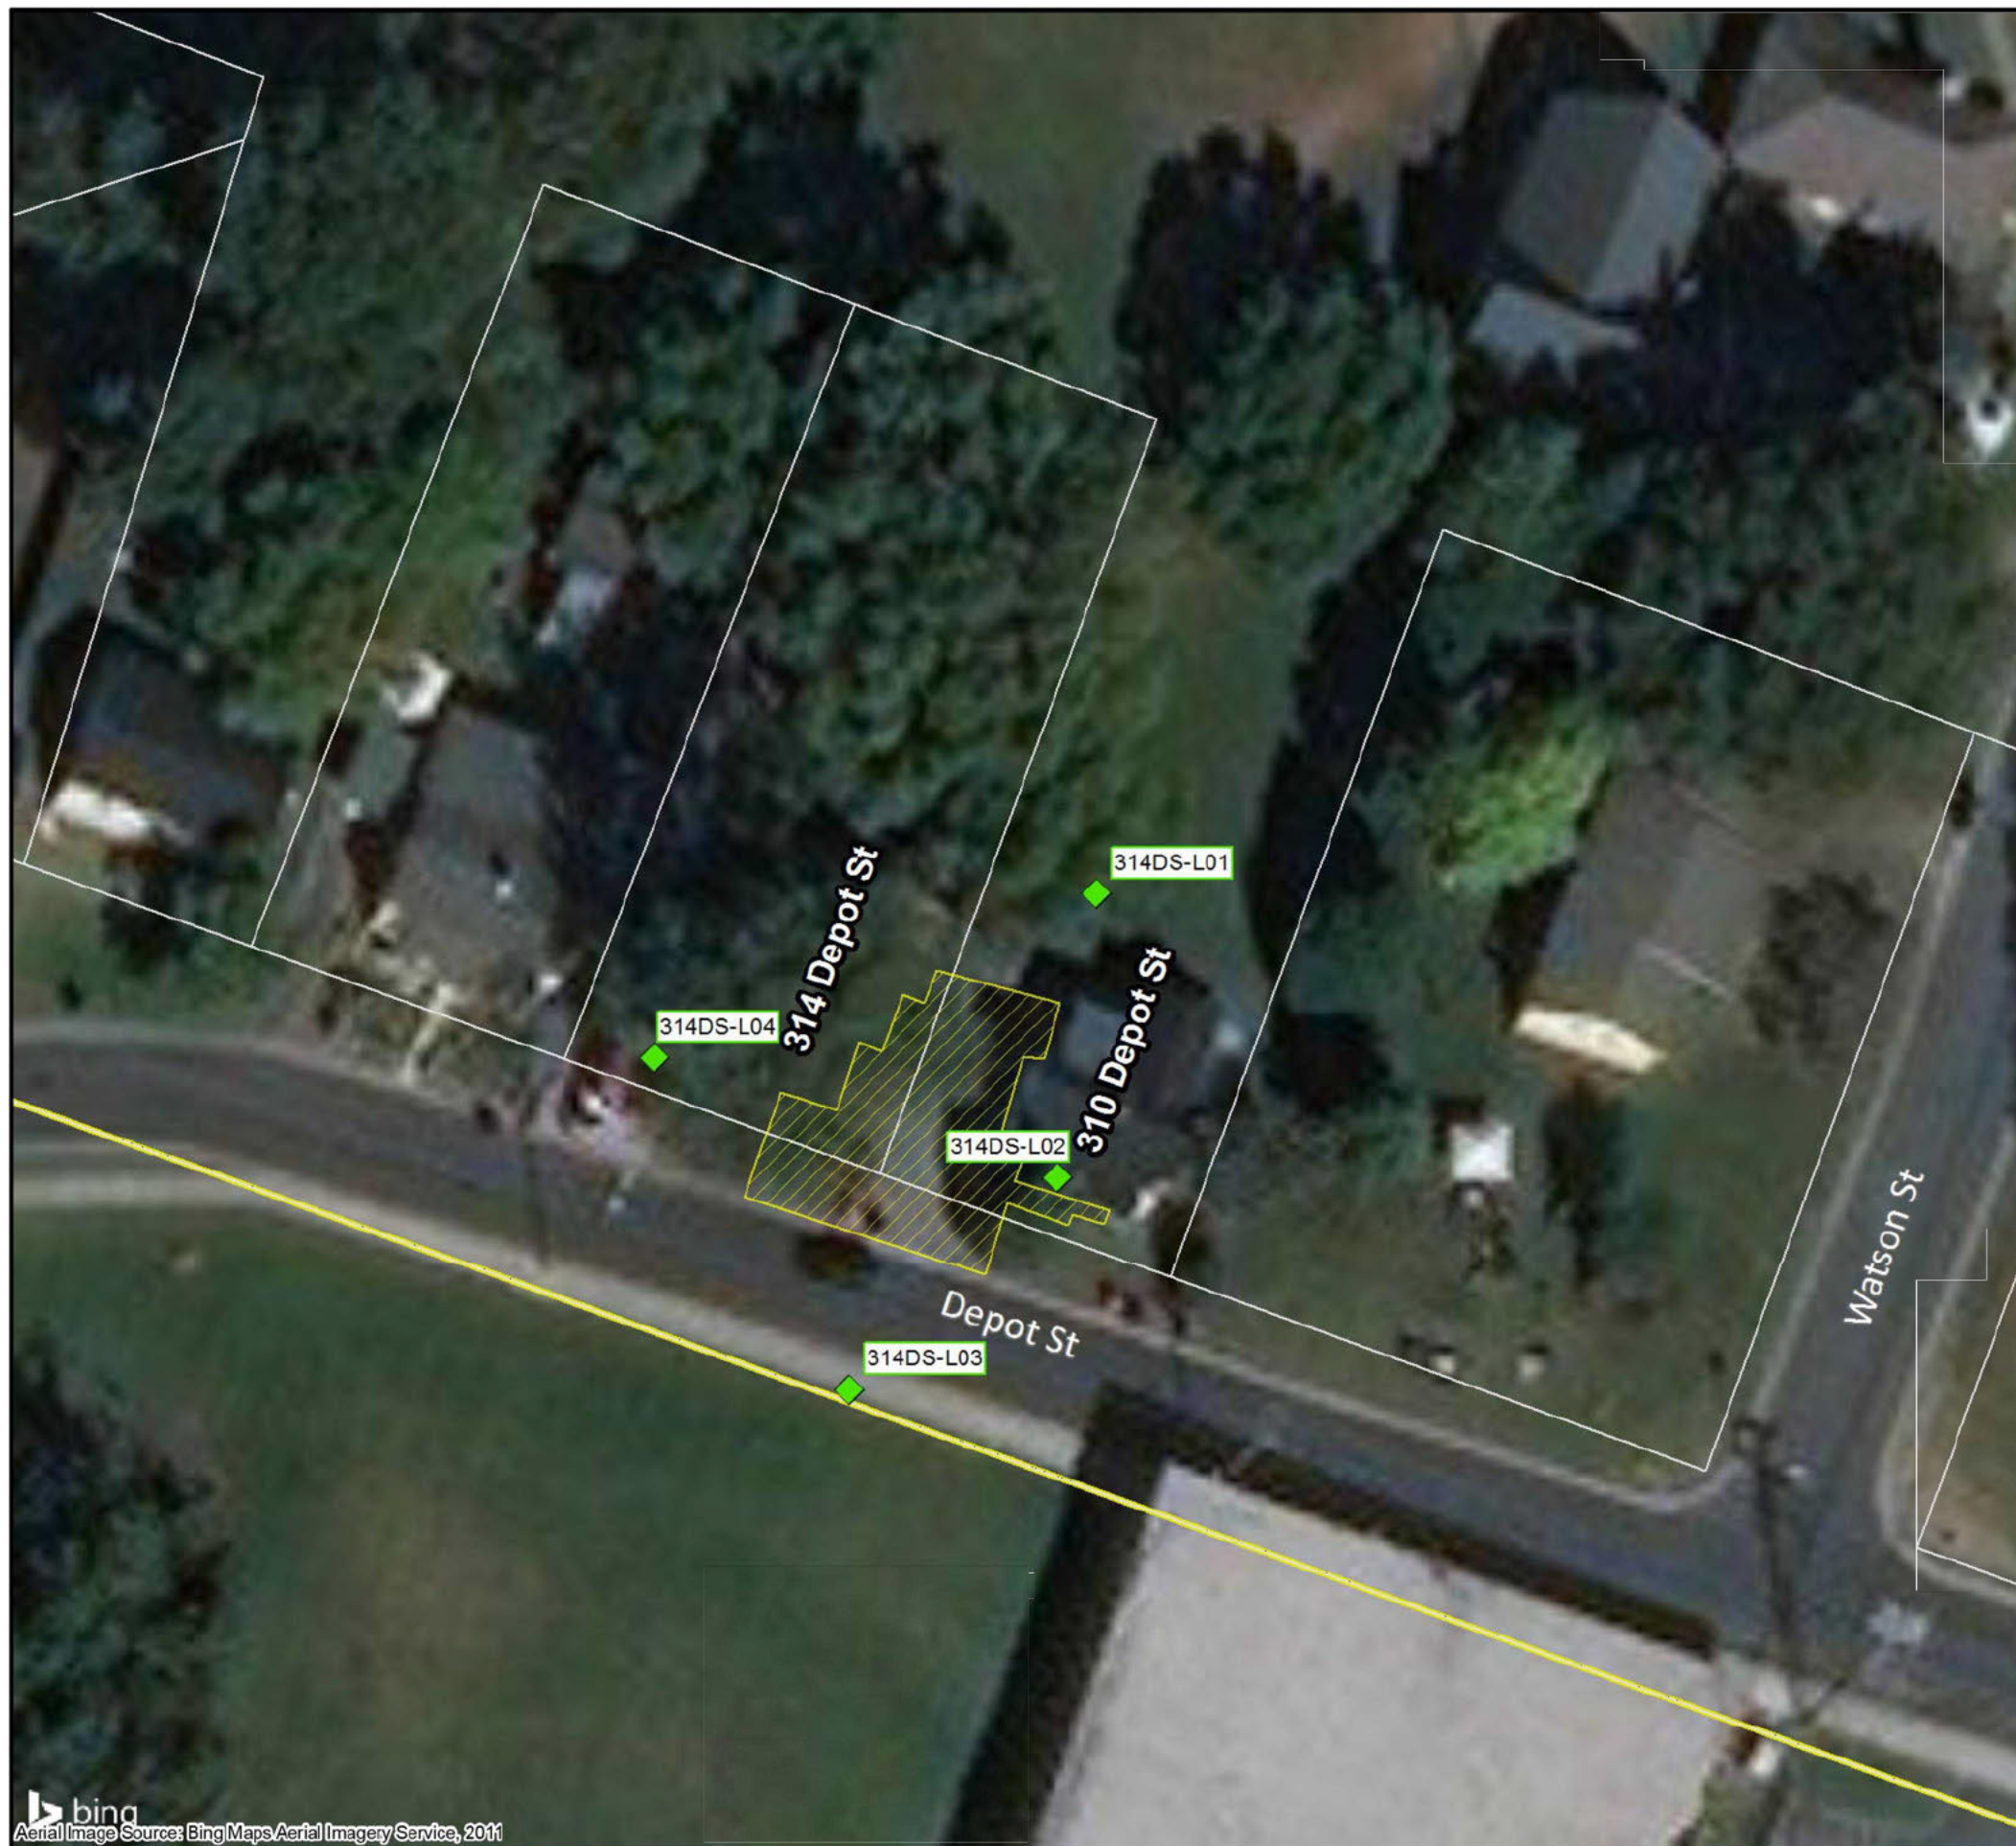
FIGURE 1

Description of Removal Action: The soil was excavated to an approximate maximum depth in the following areas: southern lawn between Sloan Street, Depot Street and eastern fence to 12 inches; and walkway between southern side of residence and retaining wall, along eastern wall, and tree line and utility pole to 3 inches (See Appendix 1). Visual inspections of the areas excavated for asbestos-containing materials (ACM) were conducted by a State of North Carolina-accredited asbestos inspector and air monitor. Additional removal was conducted in those areas where ACM were still visibly present. Once ACM was no longer visibly present, restoration of the excavated areas was allowed to commence.

Removal Areas and
Air Sampling Locations

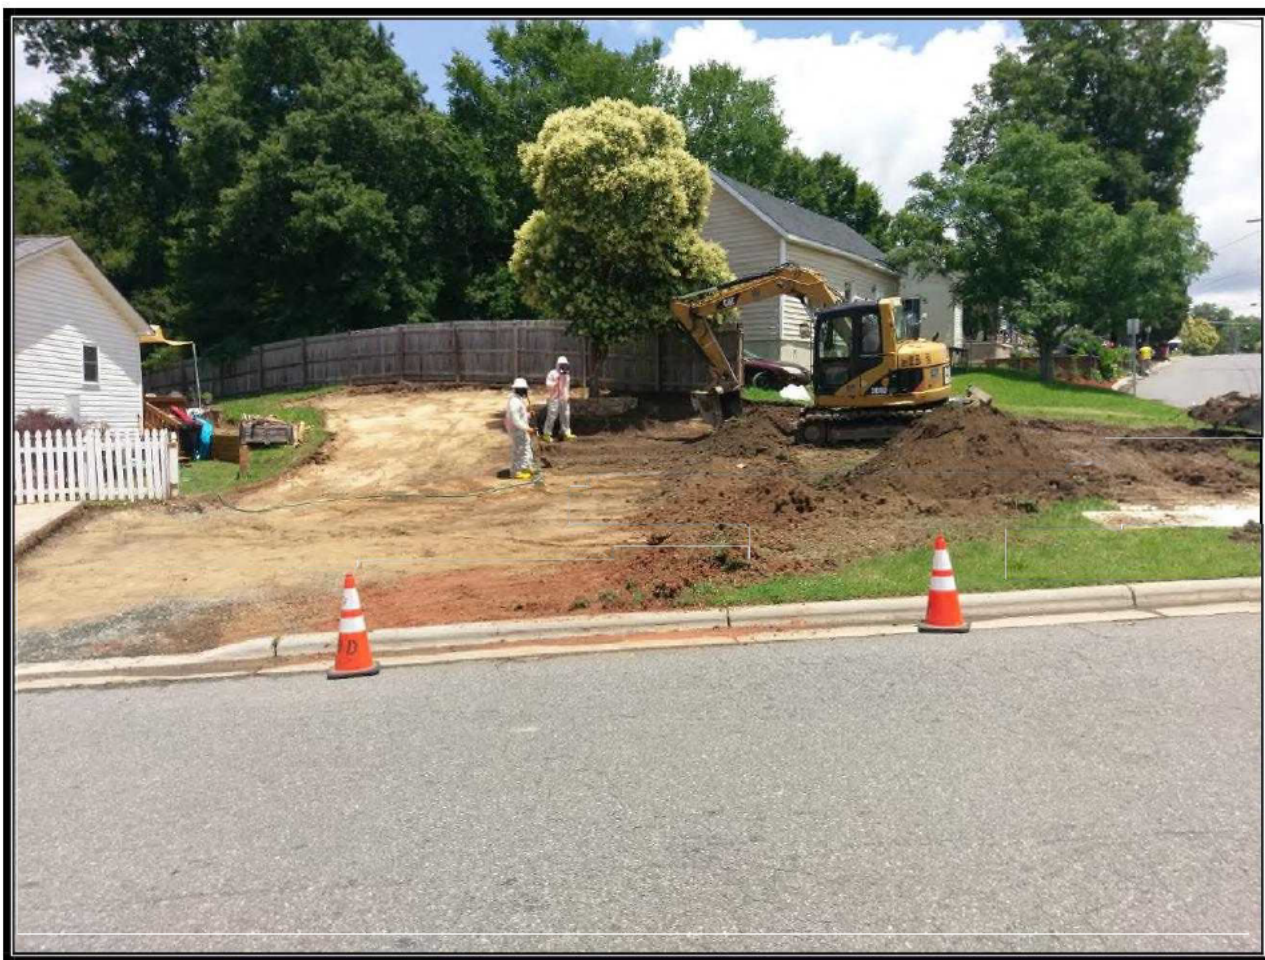
OFFICIAL PHOTOGRAPH NO. 1
U.S. ENVIRONMENTAL PROTECTION AGENCY

Subject: The Emergency and Rapid Response Services (ERRS) contractor, Environmental Restoration, LLC (ER), used an excavator and hand tools to remove asbestos-containing materials (ACM) and asbestos-contaminated soil from the property located at 302 Sloan Street. ER used hoses to wet the asbestos-contaminated soil during removal activities.

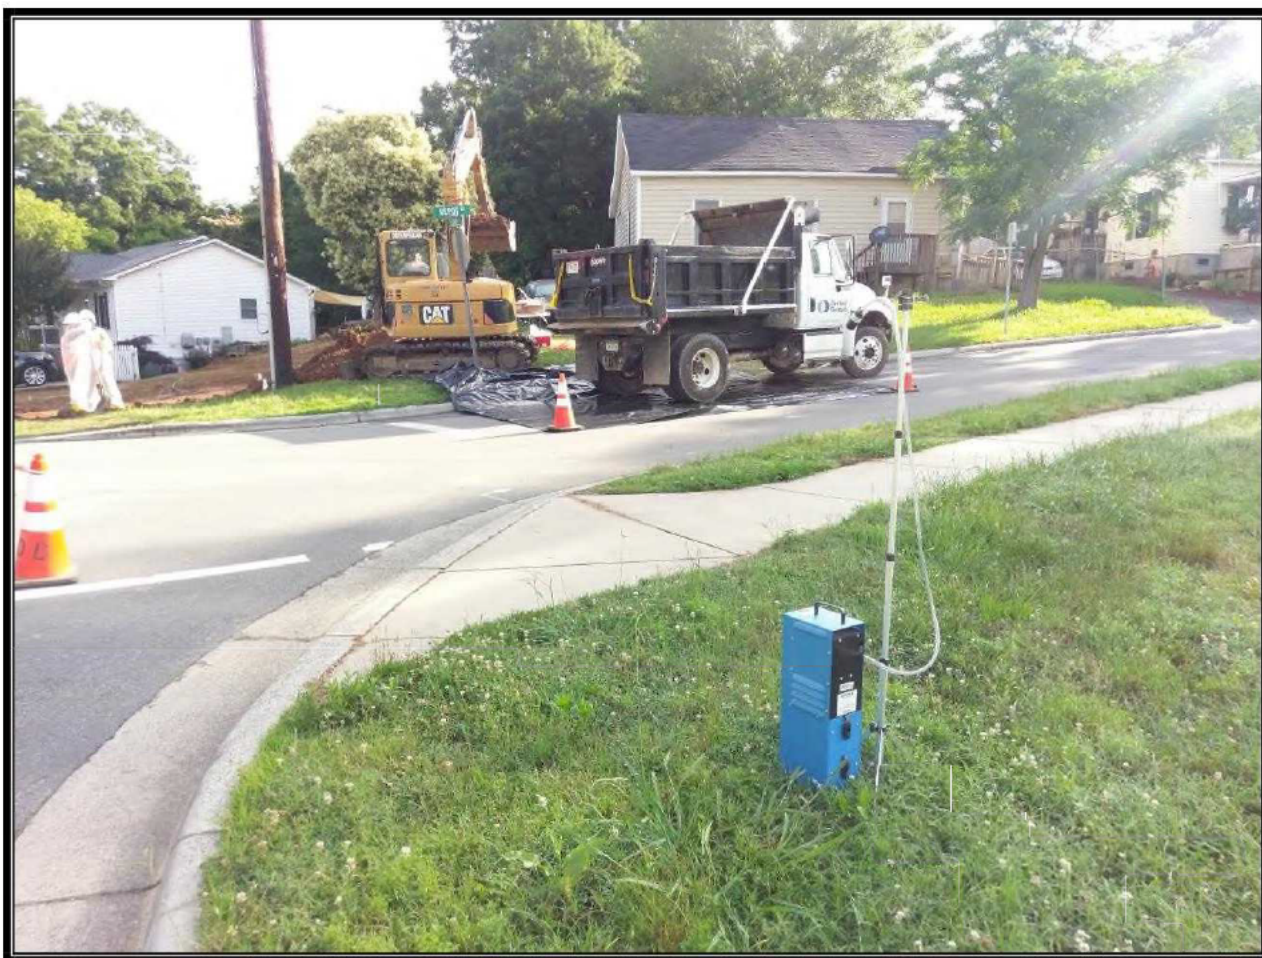
OFFICIAL PHOTOGRAPH NO. 2
U.S. ENVIRONMENTAL PROTECTION AGENCY

Subject: Perimeter air sampling was conducted by a Tetra Tech START, State of North Carolina-accredited air monitor to evaluate the effectiveness of engineering and safety controls in preventing off-site migration of asbestos fibers during removal activities.

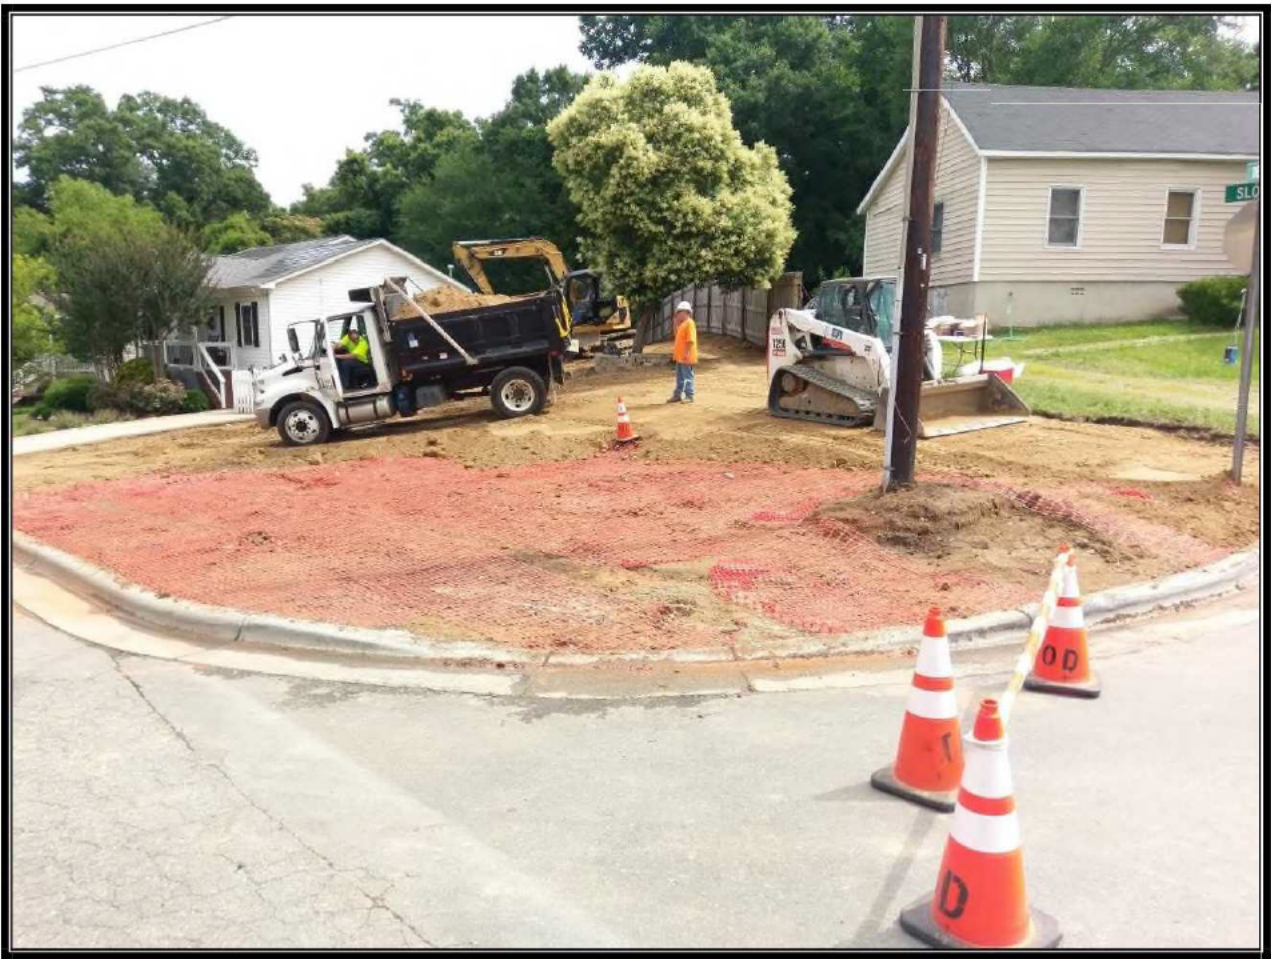
**OFFICIAL PHOTOGRAPH NO. 3
U.S. ENVIRONMENTAL PROTECTION AGENCY**

Subject: ER installed snow fencing along the subsurface of the excavated area and used dump trucks and a skid steer to install backfill after the visual inspection conducted by Tetra Tech START, State of North Carolina-accredited asbestos inspector and air monitor detected no visible ACM in the excavated area.

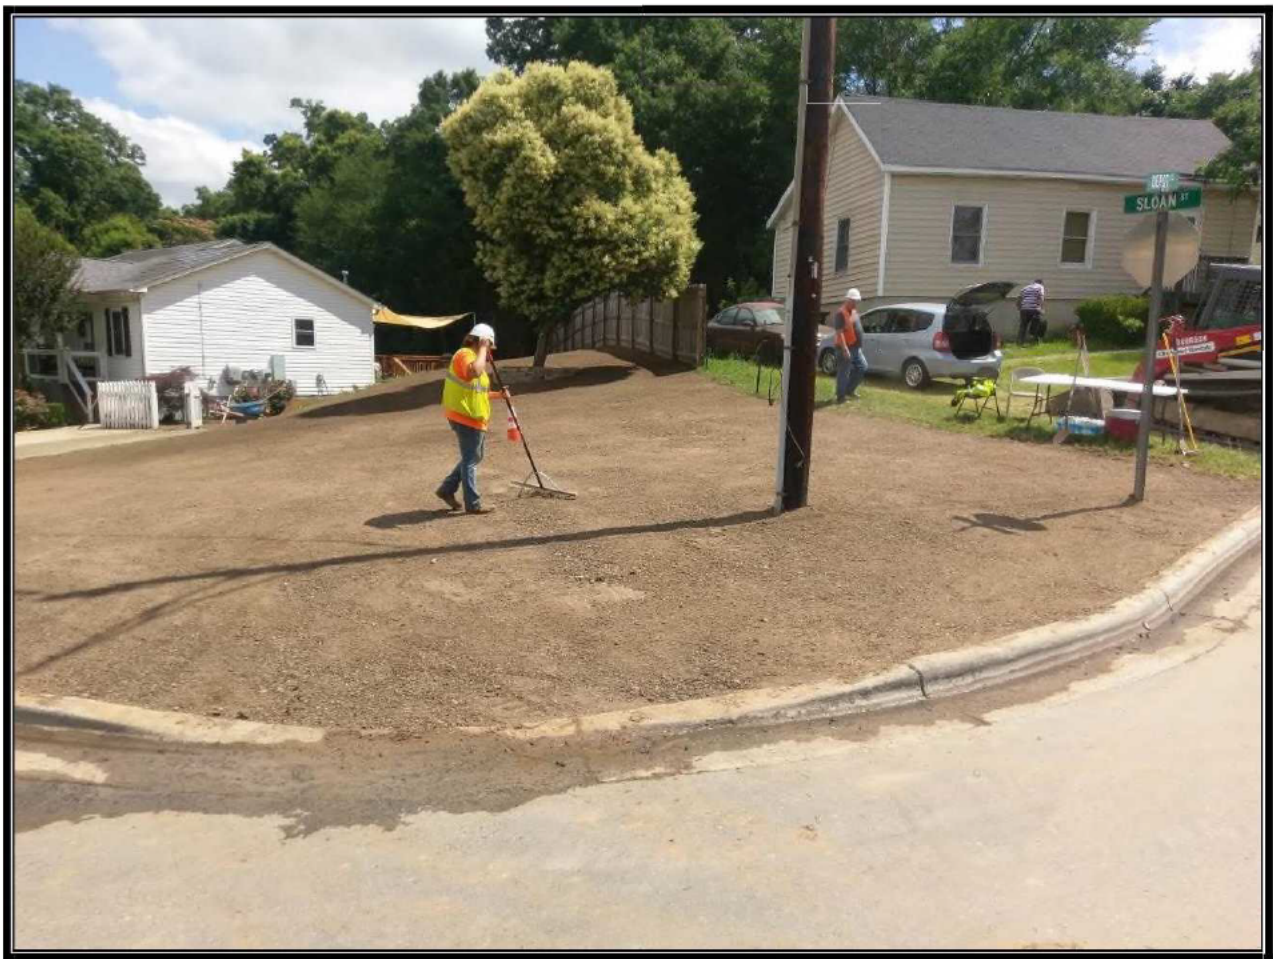
OFFICIAL PHOTOGRAPH NO. 4
U.S. ENVIRONMENTAL PROTECTION AGENCY

Subject: ER used dump trucks, skid steers, and rakes to install topsoil in the excavated areas.

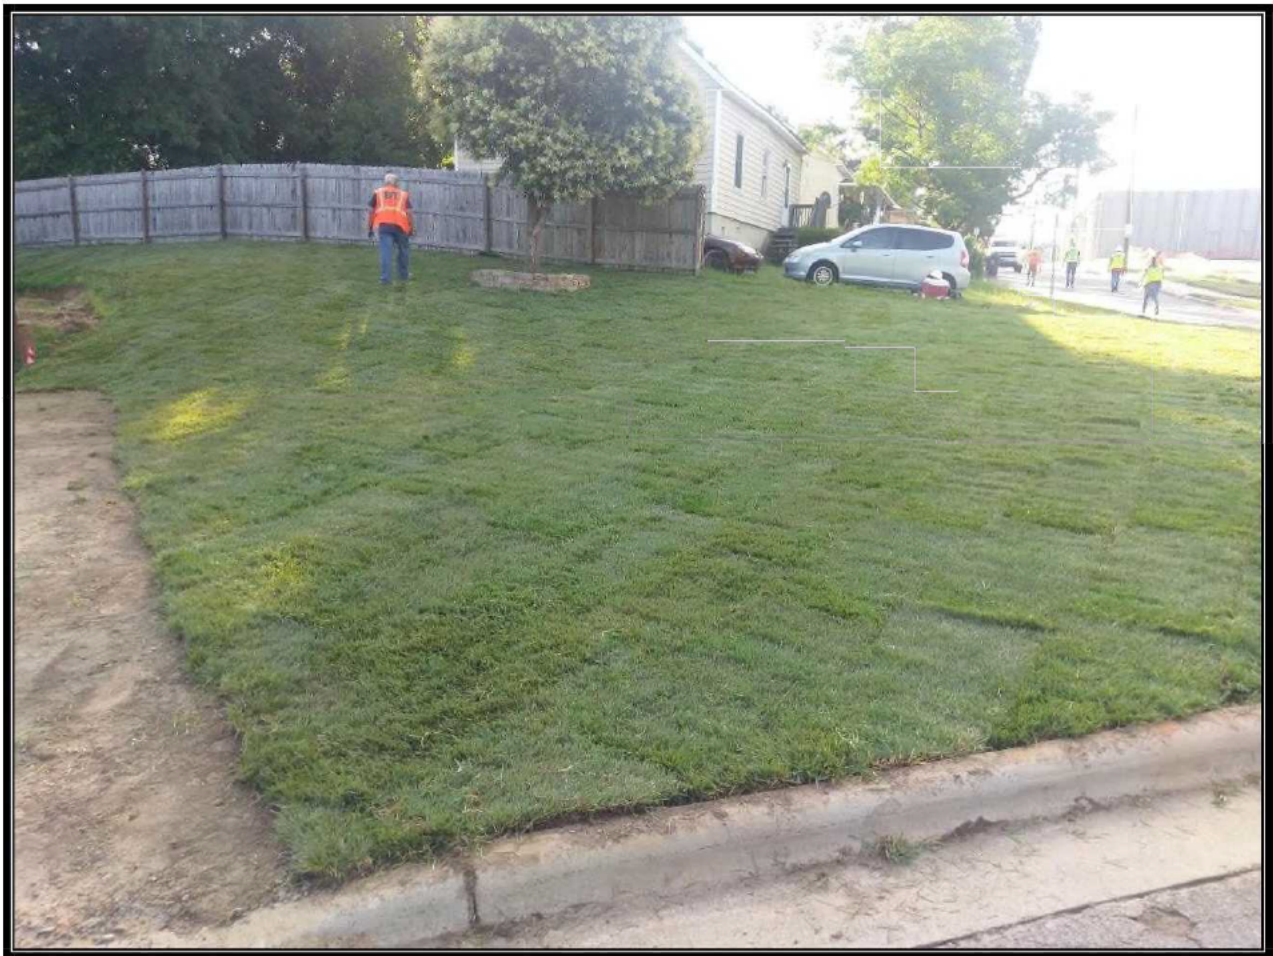
TDD Number:	TT-01-071	Location:	Davidson Asbestos
Orientation:	East	Date:	June 9, 2017
Photographer:	Paul Prys, Tetra Tech	Witness:	None
Subject:	ER installed sod in the excavated areas after backfill and topsoil were installed.
